# Manhole Inspection Summary

Manhole # S33CC\_047MH

Insp Date: **5/4/08 4:31 AM**

**Location** Address: **869 HOWARD ST**

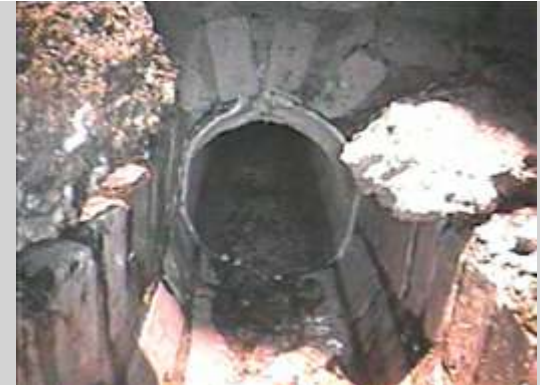
12 O'Clock Outflow

DEBRIS ON BENCH

Pipe Material: **Clay** ☒ Pipe Lined

Invert Depth: **15.33** (ft.) Flow Characteristics: **Slow**

Infiltration: **None** Pipe Seal Cond: **Sound**

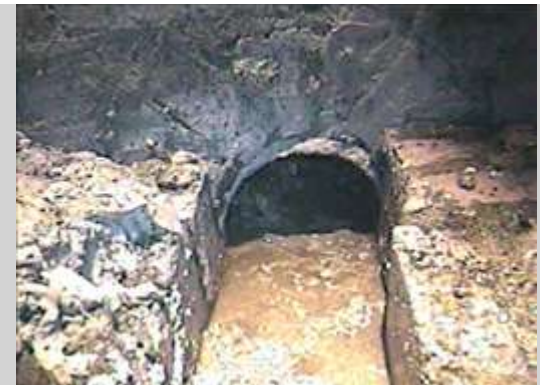
4 O'Clock Inflow

8 in. Circular Gravity Sewer  
Pipe In @ 4 O'Clock

Deposits: ☐ None ☒ **Mud** ☐ Sludge ☒ **Debris** ☐ Grease

Silt Depth: **4** (in.) Deposits Extent: **Heavy**

Infiltration: **None** Pipe Seal Cond: **Sound**

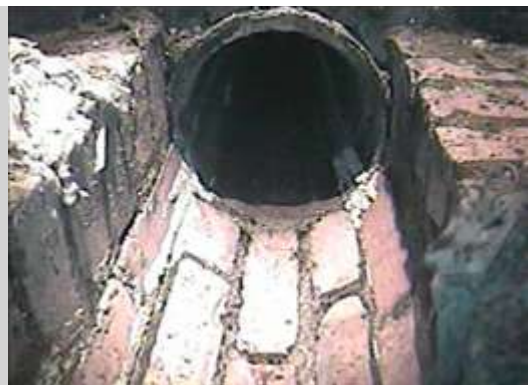
7 O'Clock Inflow

Pipe Material: **Clay** ☒ Pipe Lined

Invert Depth: **15.30** (ft.) Flow Characteristics: **Slow**

Infiltration: **None** Pipe Seal Cond: **Sound**
